# Strength & Inside Edition FAQ

The following article covers Strength & Inside Edition FAQ.

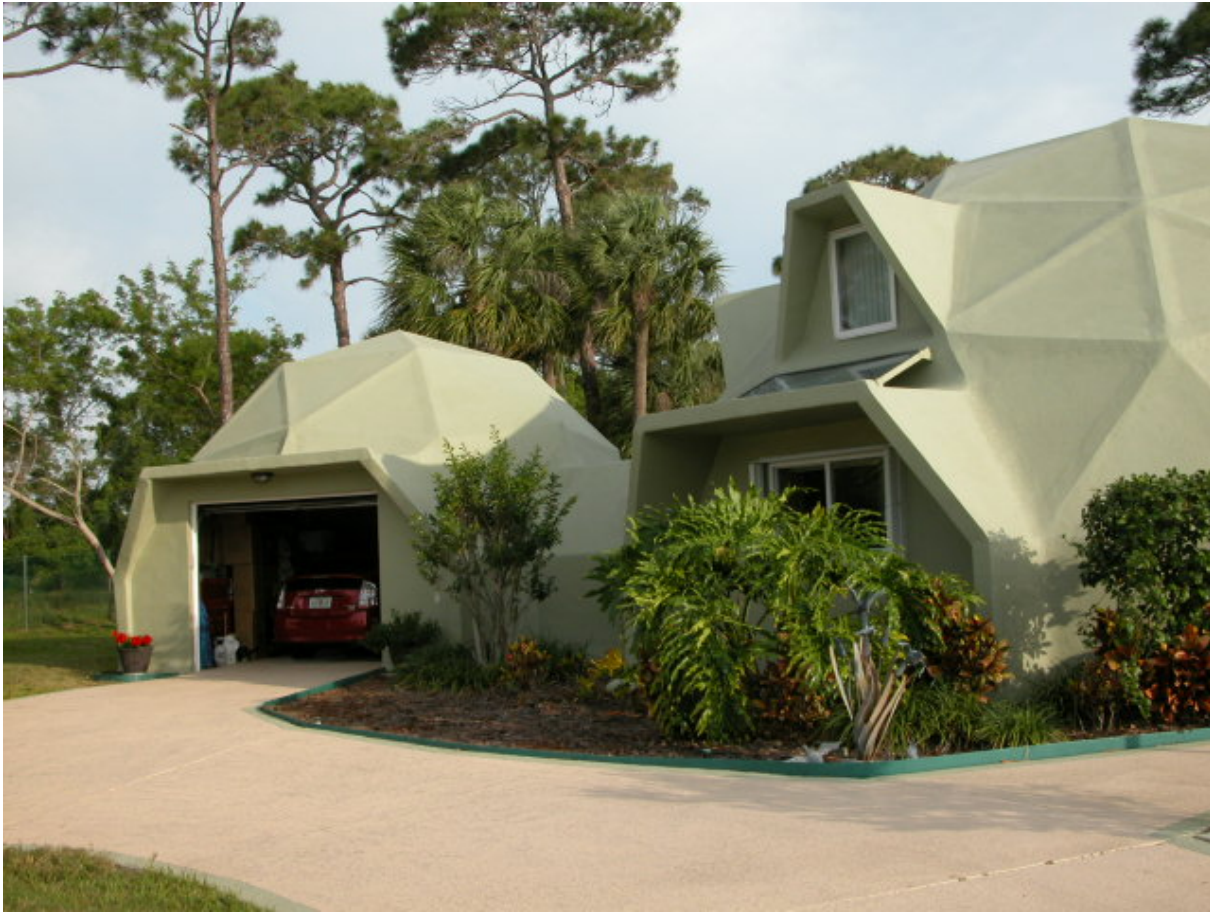
Above is the 22' dome linked to 34' dome that were under construction when Inside Edition Visited

These Domes Went Through Hurricane Jeanne and Frances with no damage.

While the roof was blown off the house across the street

The next stop was to view our domes under construction in Melbourne, Florida, a 34' dome linked to a 22' garage. Also of interest was the interior metal framing and metal floor joists.
